PLAIN NINE DAM

NDI I.D. NO: 520

6 PHASE I INSPECTION REPORT  
NATIONAL DAM INSPECTION PROGRAM.

Plain Nine Dam (NDI 520), Susquehanna  
River Basin, Blair Gap Run, Blair County,  
Pennsylvania. Phase I Inspection Report.

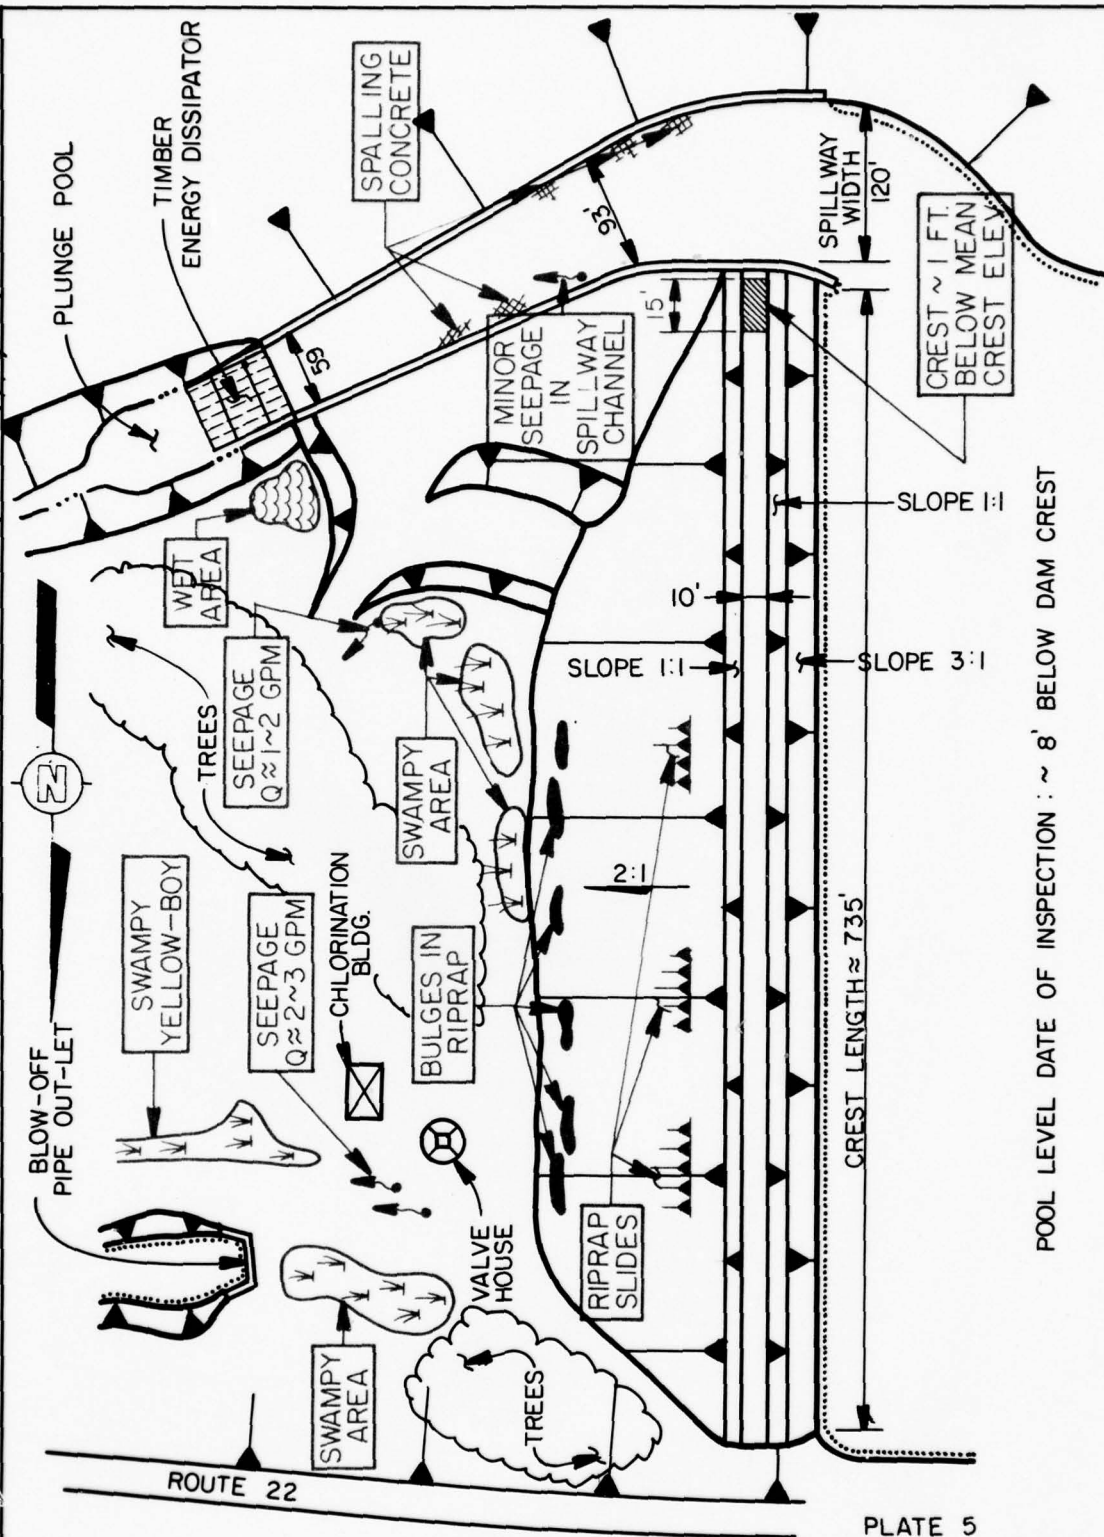
PLAIN NINE DAM NDI ID: 520  
 GENERAL PLAN  
 FIELD INSPECTION NOTES  
 FIELD INSPECTION DATE: JUNE 8, 1978

VISUAL EXAMINATION OF	OBSERVATIONS	REMARKS OR RECOMMENDATIONS
JUNCTION OF EMBANKMENT AND ABUTMENT, SPILLWAY AND DAM	NO VISUAL SIGNS OF DISTRESS, NO SEEPAGE	
ANY NOTICEABLE SEEPAGE	NO SEEPAGE ON EMBANKMENT. SOME SEEPAGE AND WET AREAS BELOW TOE. SEE PLATE 5 FOR LOCATION	
STAFF GAGE AND RECORDER	NONE	
DRAINS	NONE FOUND.

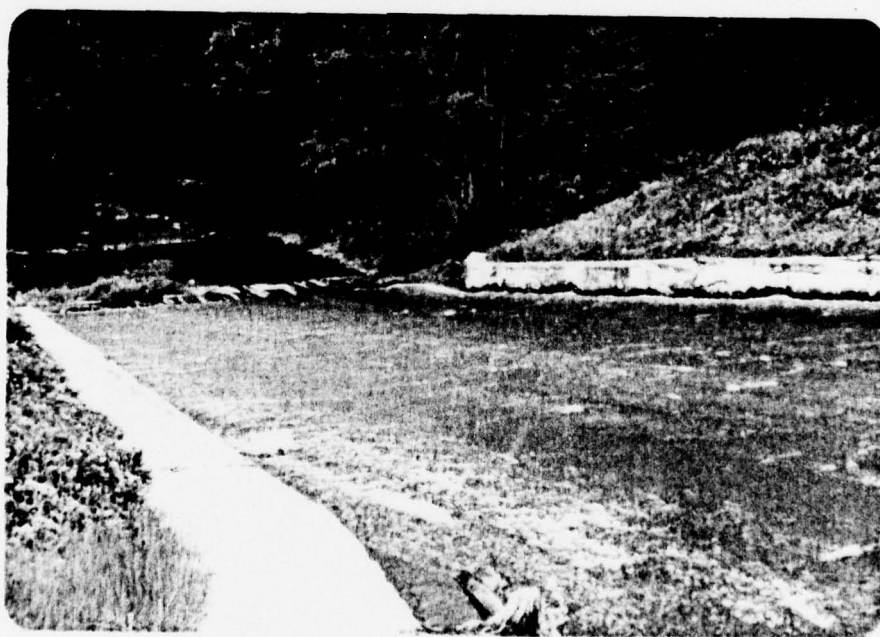
Photograph No. 4  
Spillway chute and plunge pool.

Minor seepage along the walls of the spillway channel and spalling on the channel walls were observed. The condition of the timber energy dissipator was considered to be fair.

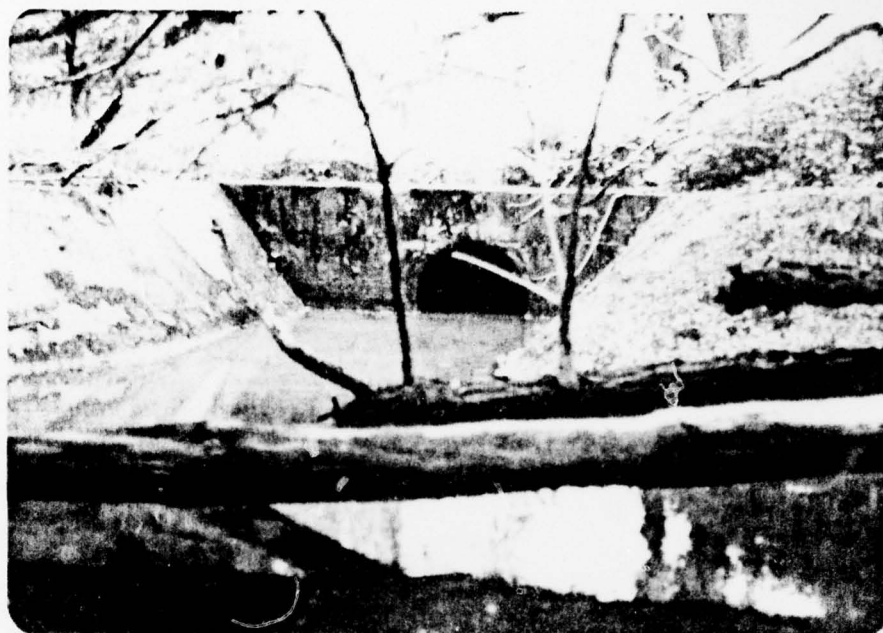
Photograph No. 5  
"Blow-off" pipe outlet.

4.3 Maintenance of Operating Facilities. The water company declined to operate the blow-off valve to demonstrate its functional condition without compensation for operation and for any damages that would result due to this operation. Therefore, the operational condition of the blow-off pipe could not be assessed.

1. The owner should initiate additional hydrology and hydraulic studies to more accurately ascertain the spillway capacity and the nature and extent of improvements required.
2. It is recommended that the owner immediately evaluate the operational condition of the lake blow-off valve and perform any necessary maintenance.
3. Since the adequacy of the concrete encasement around the pipes through the embankment could not be reliably assessed, the owner should evaluate the structural integrity of the pipes and encasement and place at least temporary upstream controls on these pipes for periodic inspection and use in the event of an emergency (rupture of the pipes).

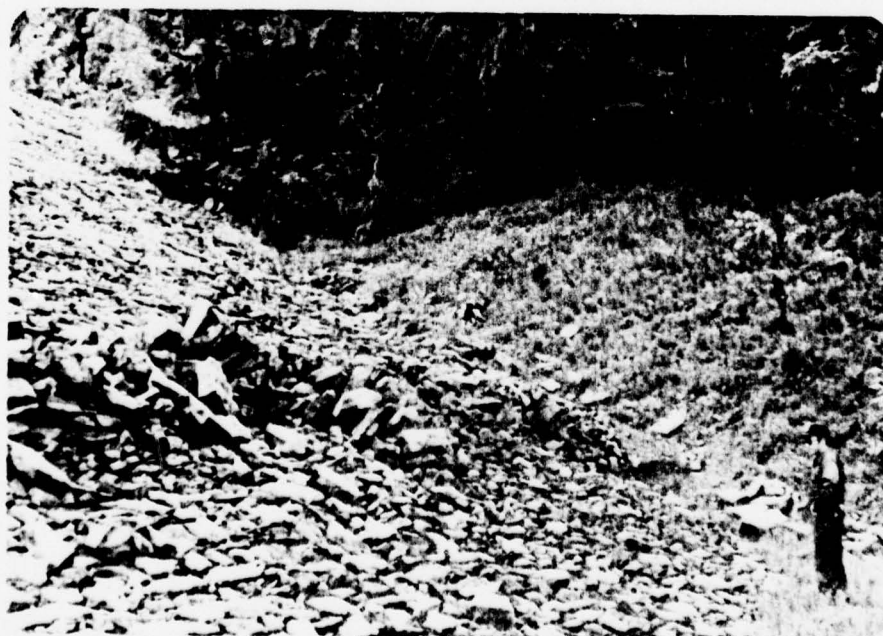
1. Two swampy areas were observed at the toe area of the dam; one located to the right of the center of the embankment adjacent to the toe and another near the left abutment about 120 feet from the toe. Only minor seepage (one to two gpm) was associated with these wet areas.
2. One of the wet areas near the left abutment contained acid mine drainage precipitate (yellow boy). However, the extent of precipitate accumulation is not considered to be significant.
3. Numerous bulges in the riprap on the downstream slope located near the toe of the dam were observed. The appearance of these bulges suggests that they are a result of buckling of the riprap layer as it moves downslope over the fill material.

3.2 Evaluation. In general, the condition of the dam is considered to be good. Minor seepages and wet areas located below the toe of the dam are not considered to have a significant effect on the stability of the dam at this time. The bulges on the downstream slopes appear to be a result of surficial sliding of riprap. No indications were found that these bulges are related to deep-seated slides in the downstream slope.

Photograph No. 6  
Typical bulges in downstream face riprap.

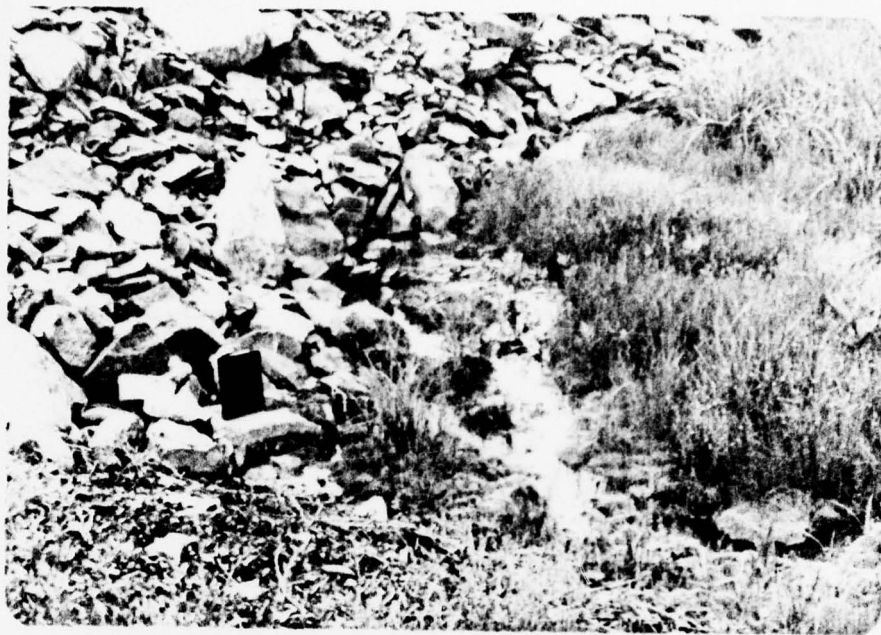
Photograph No. 7

Seepage at toe.

4. It is recommended that the owner monitor and record seepage quantities regularly and observe the turbidity of the seeps. The condition of swampy areas in the vicinity of the toe should also be periodically observed. If the conditions worsen, remedial measures should be taken.
5. It is recommended that the owner should provide around-the-clock surveillance during unusually heavy runoff and develop a formal warning system to alert the downstream residents in the event of an emergency.
6. It is recommended that the owner be advised that the dam and appurtenant structures should be inspected regularly and adequately maintained.

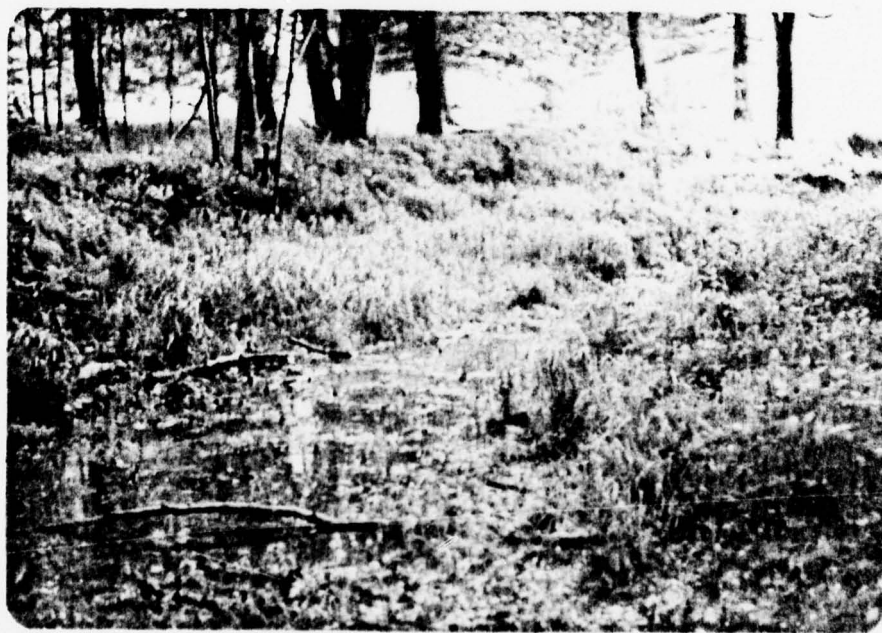
Photograph No. 8

Seepage at toe (note yellow boy).

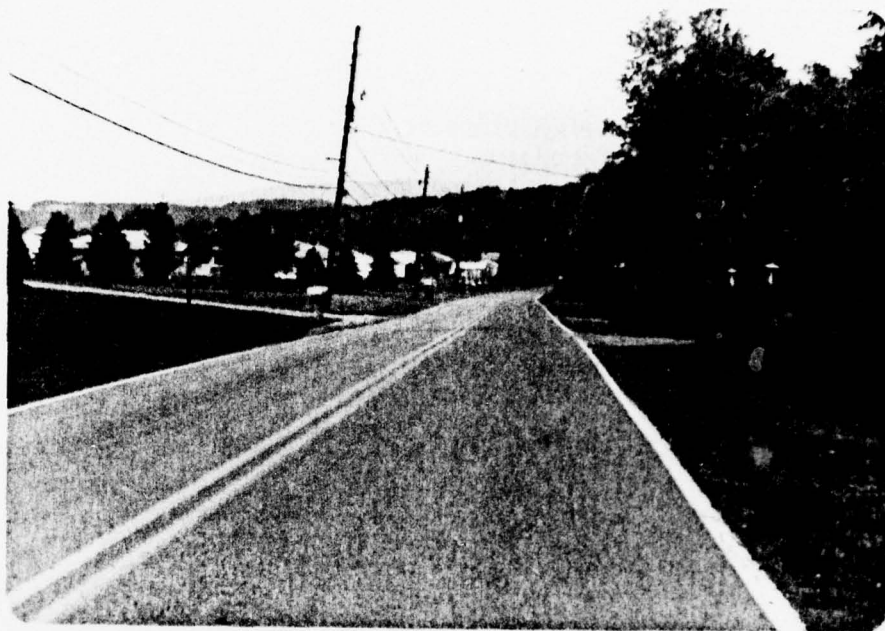
Photograph No. 9

Typical flood plain, two miles downstream.  
(Stream off the photograph on the right is  
approximately 10 feet below road level.)

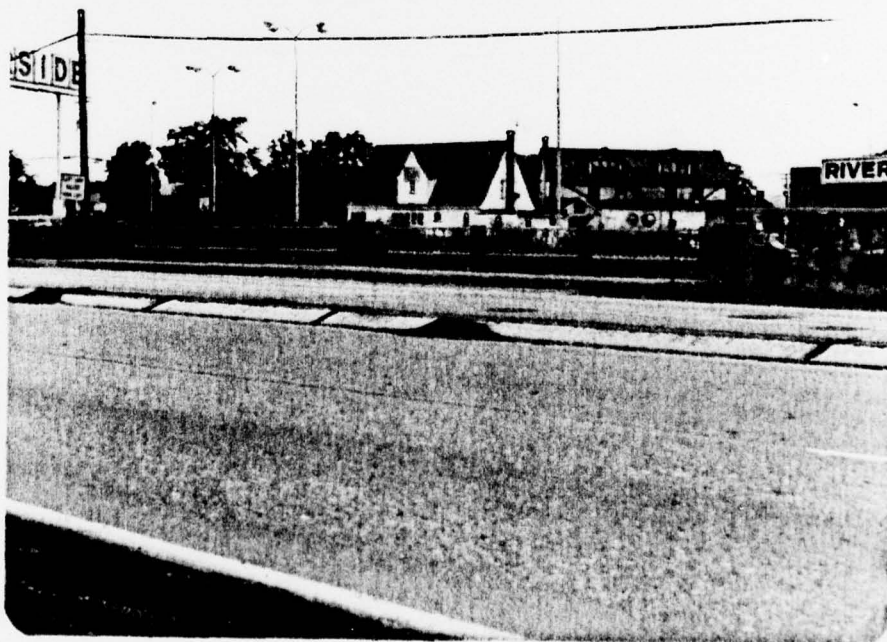
Photograph No. 10

Bridge on Blair Gap Run at Duncansville.  
(Route 220, 4 miles downstream.)
